NORWEGIAN HULL CLUB

Casualty Information

No. 101 – June 2019

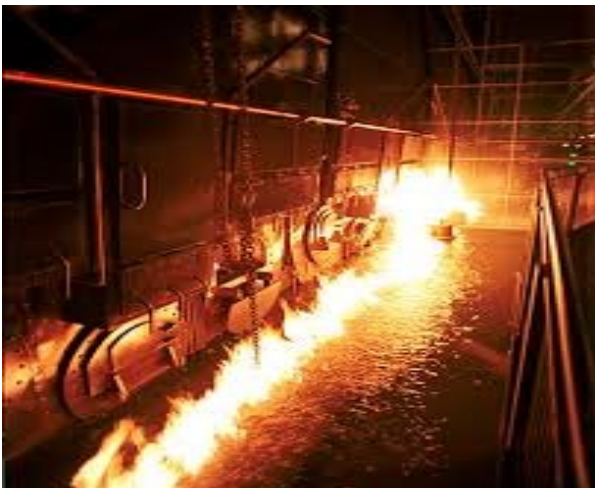
Example: Fuel oil ablaze after spraying onto hot surface

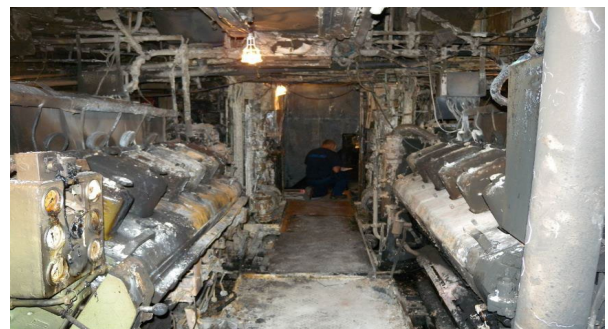
Example 1 – Fire in Cruise Vessel Engine Room

The above shows the aftermath of a blaze in the engine room of a cruise vessel, caused by fuel oil leakage.

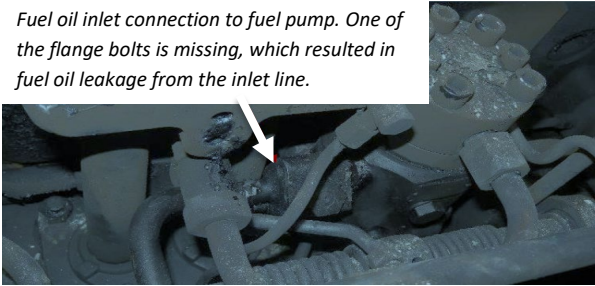
Fuel oil inlet connection to fuel pump. One of the flange bolts is missing, which resulted in fuel oil leakage from the inlet line.

The bolt was later found below the flange connection.

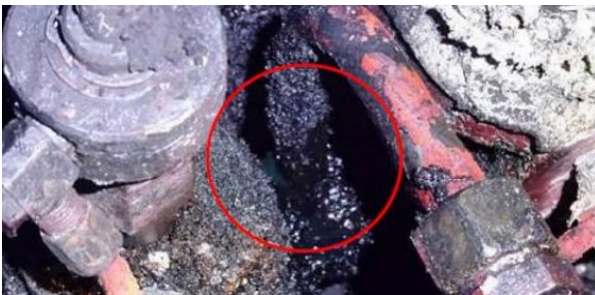
Example 2 – Offshore Vessel

The above photograph shows evidence of leakage from the fuel return line.

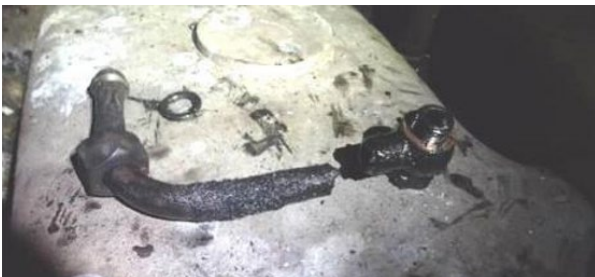
A broken fuel-return line from the HP fuel pump.
