FINFISH AQUACULTURE SITE AQUACULTURE STEWARDSHIP COUNCIL REPORT HECATE CHANNEL, HECATE CHANNEL, BC

SITE LICENSE: AQ1862

SURVEY TYPE: ASC

SURVEY DATE: FEBRUARY 11, 12 AND 17, 2021

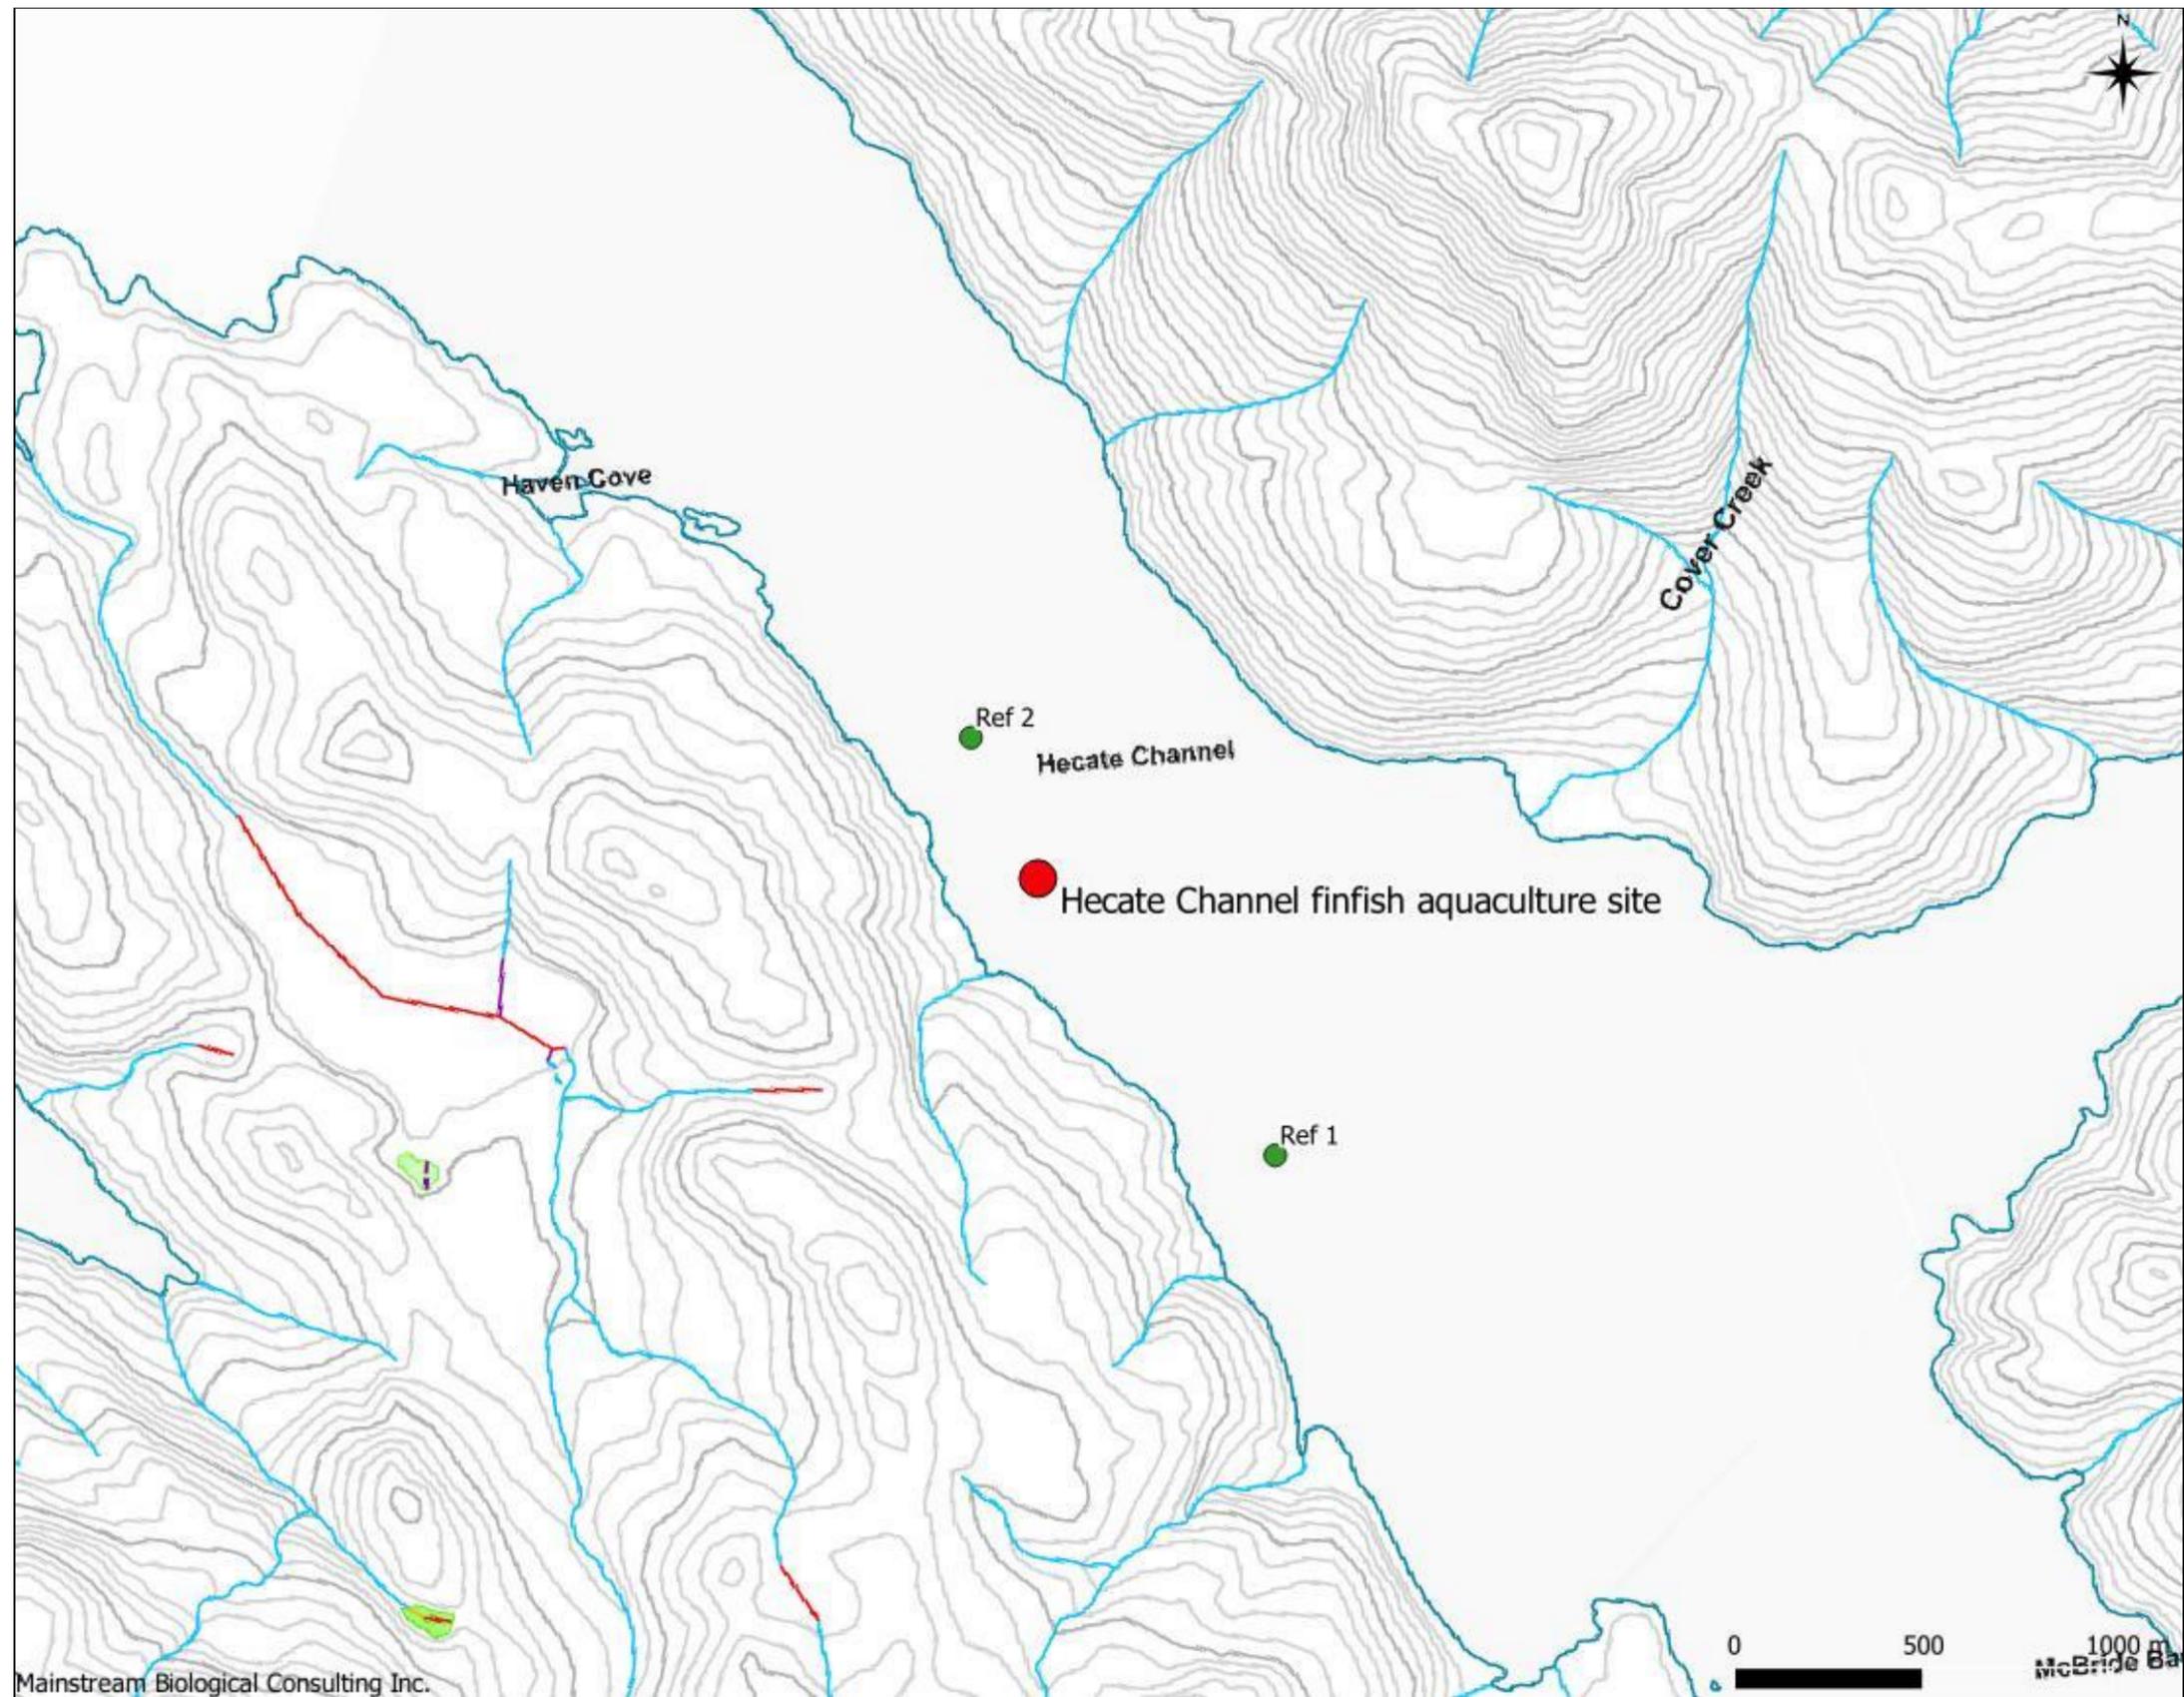
Figure 3: The locations of the reference stations for the ASC survey at the Hecate Channel finfish aquaculture site in relation to the site and surrounding area on February 11, 12, and 17, 2021.

Individual sediment sampling stations were located along three transects (Transects A, B, and C). Stations within the AZE were located 5 m inside the 1 g DEPOMOD contour (Figure 2) for all three transects. Stations outside the AZE were located 25 m outside of the 1 g DEPOMOD contour and stations were also located at the perimeter of the containment system for Transects A and B. Additional stations were established at two reference sites within the range of 500 m to 1000 m from the aquaculture containment system as outlined in the ASC Salmon Standard (Figure 3).

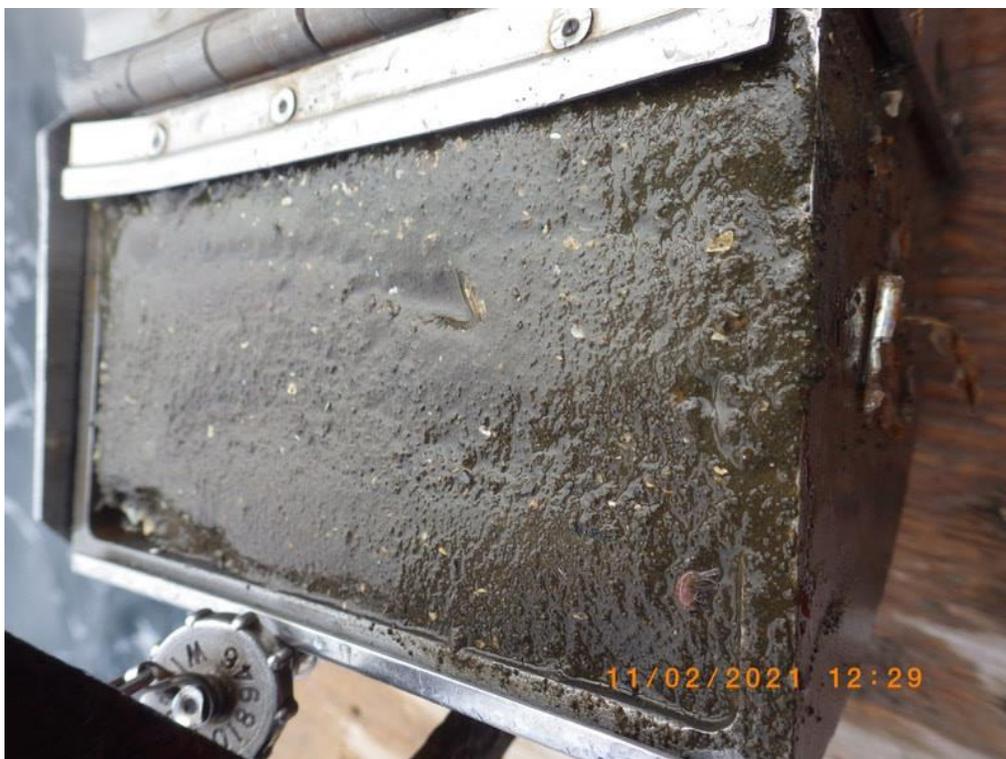
Photo 1

Sediment sample collected at Station 0A at the Hecate Channel site on February 11, 2021.

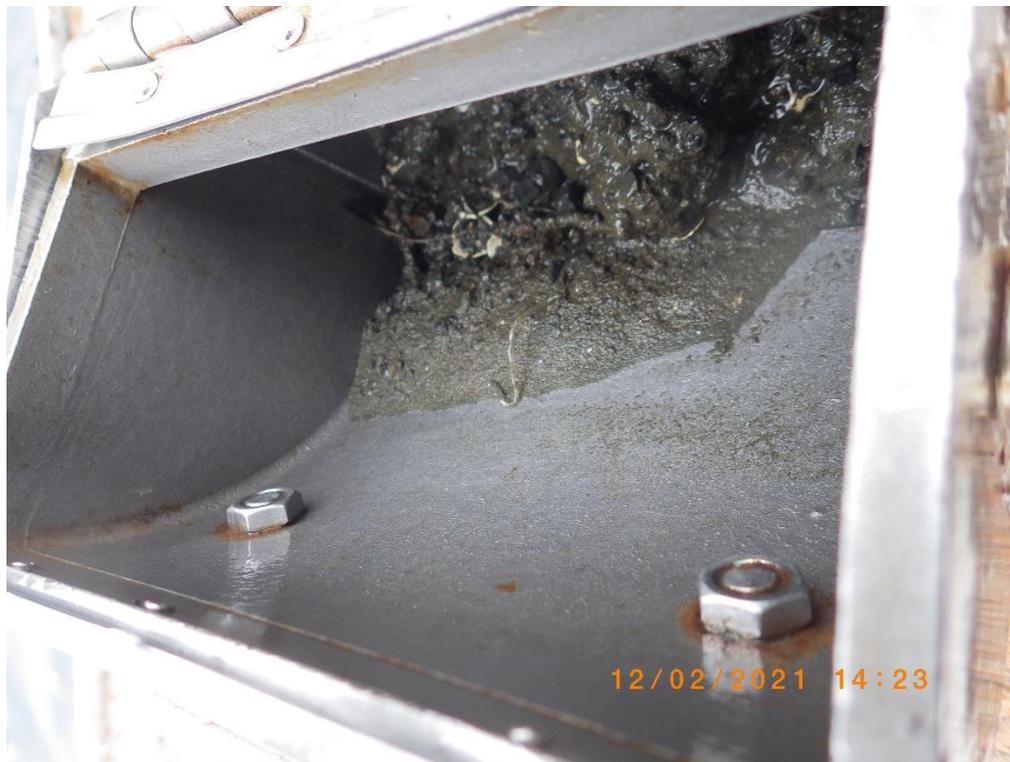
Photo 2

A typical unsuccessful grab attempted inside the AZE on Transect A at the Hecate Channel site on February 12, 2021.

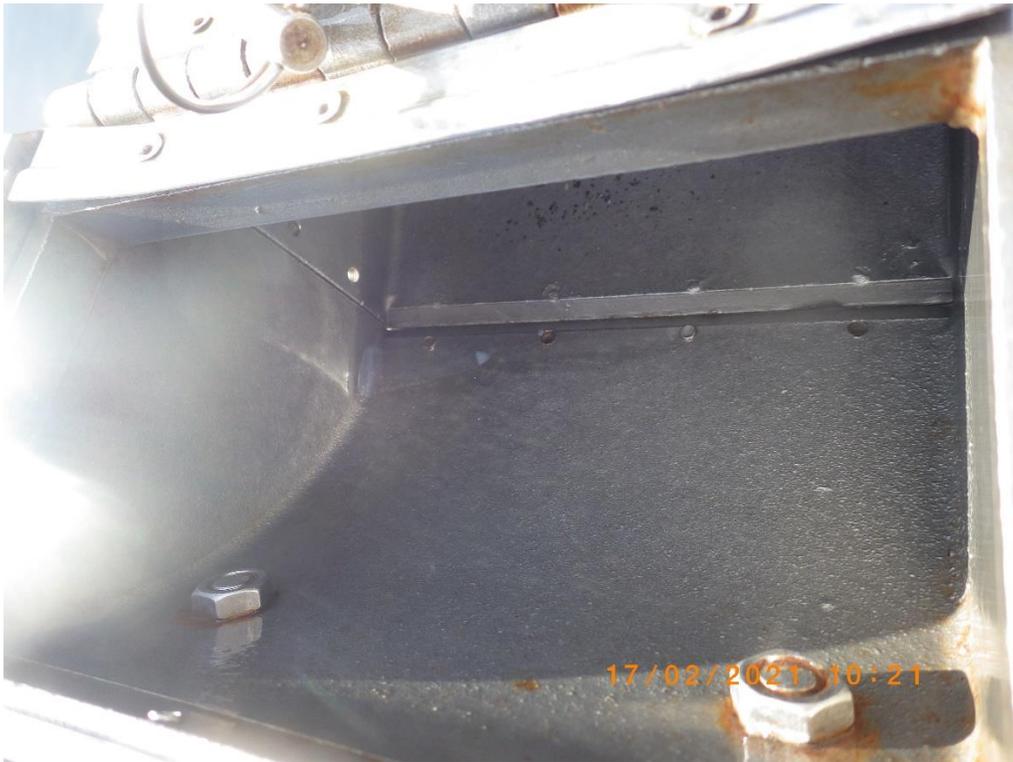
Photo 3

A typical unsuccessful grab attempted at Station 0B at the Hecate Channel site on February 17, 2021.

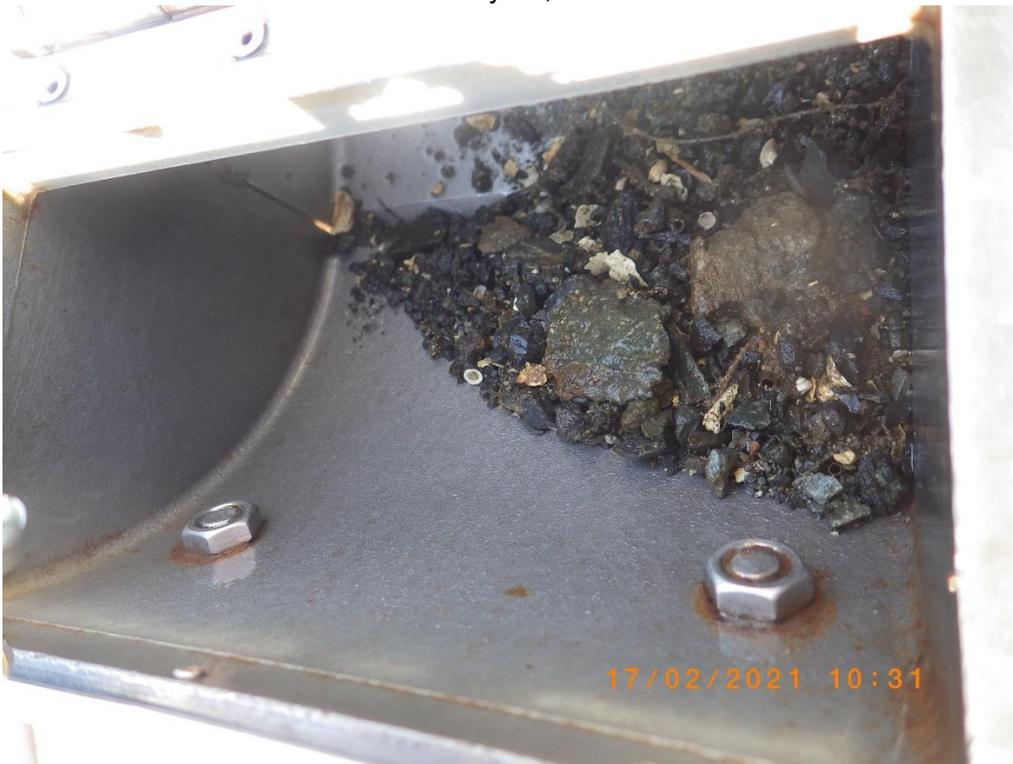
Photo 4

A typical unsuccessful grab attempted inside the AZE on Transect B at the Hecate Channel site on February 17, 2021.

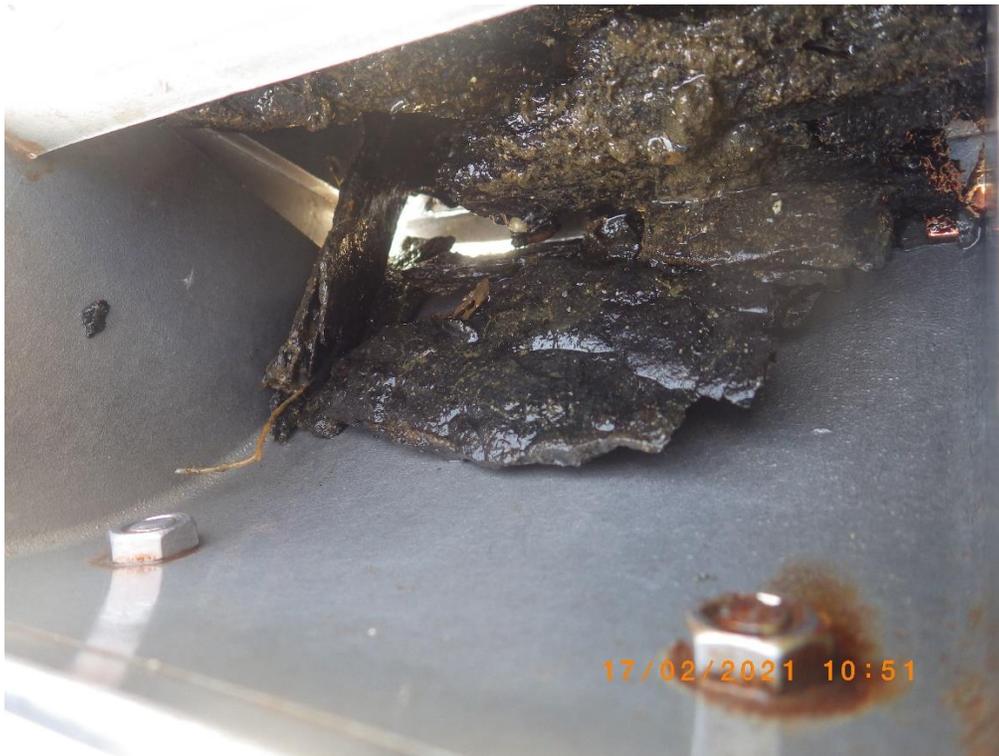
Photo 5

A typical unsuccessful grab attempted outside the AZE on Transect B at the Hecate Channel site on February 17, 2021.

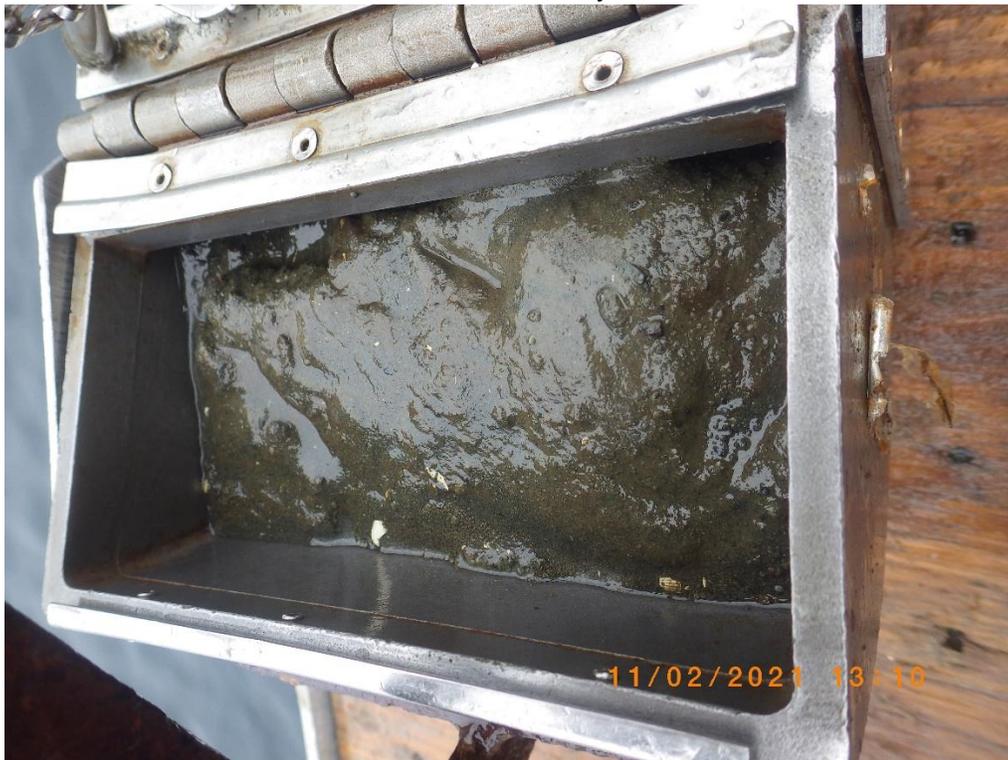
Photo 6

Sediment sample collected inside the AZE on Transect C at the Hecate Channel site on February 11, 2021.

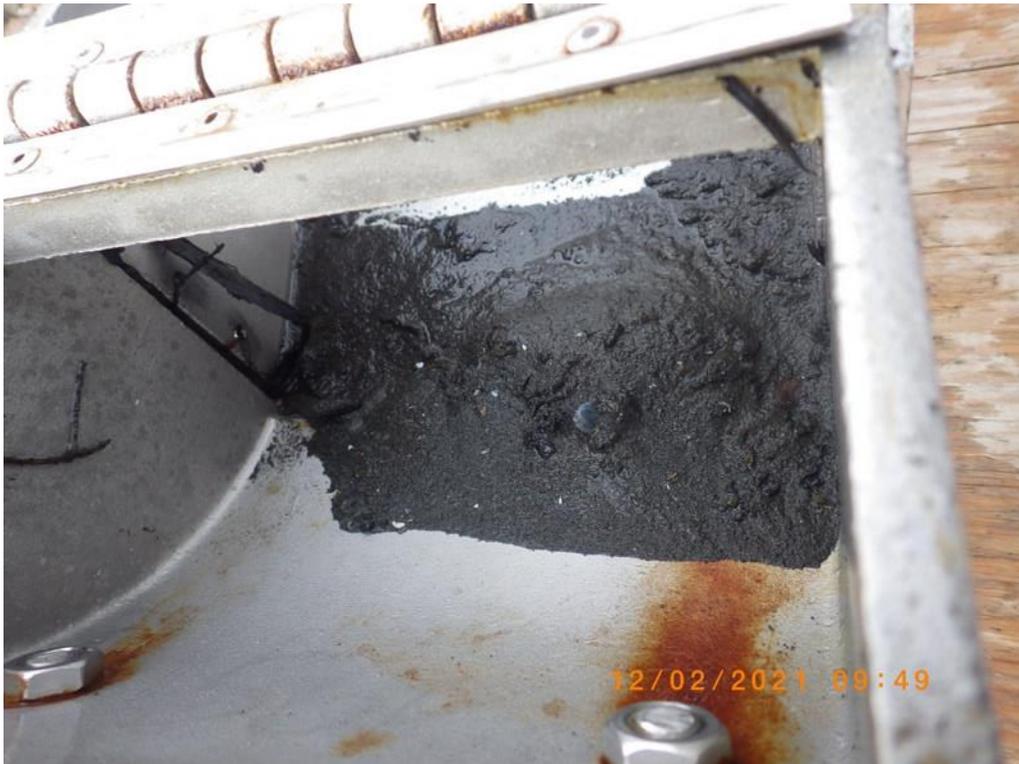
Photo 7

A typical unsuccessful grab attempted outside the AZE on Transect C at the Hecate Channel site on February 12, 2021.

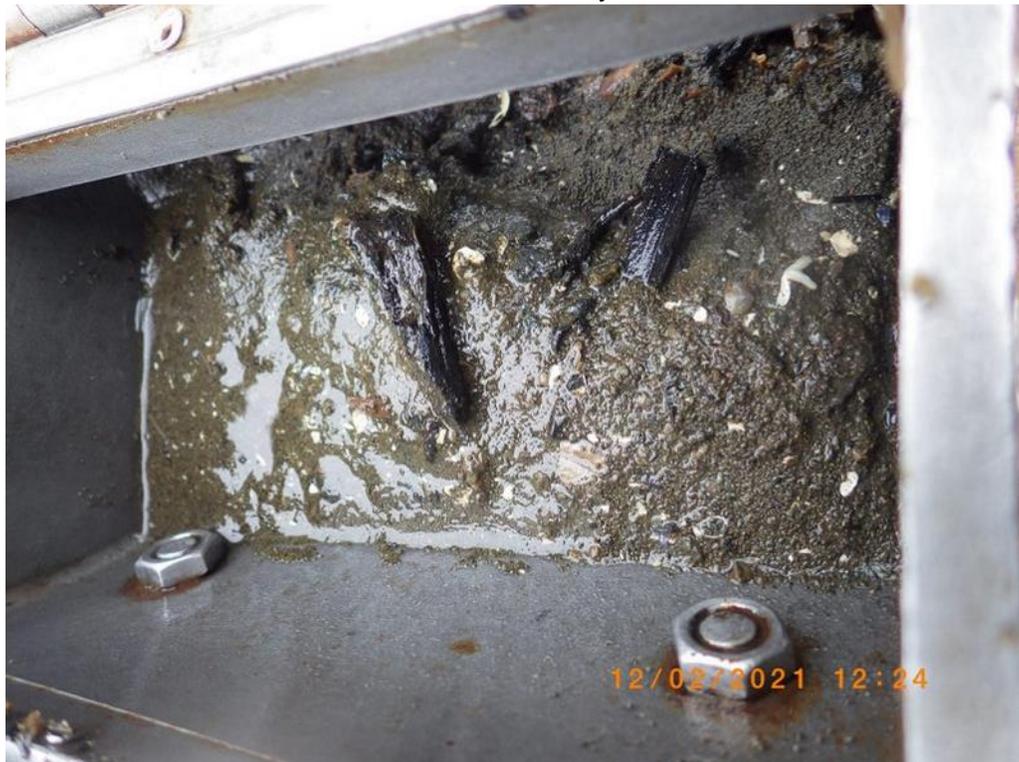
Photo 8

Sediment sample collected at Reference 1 at the Hecate Channel site on February 12, 2021.

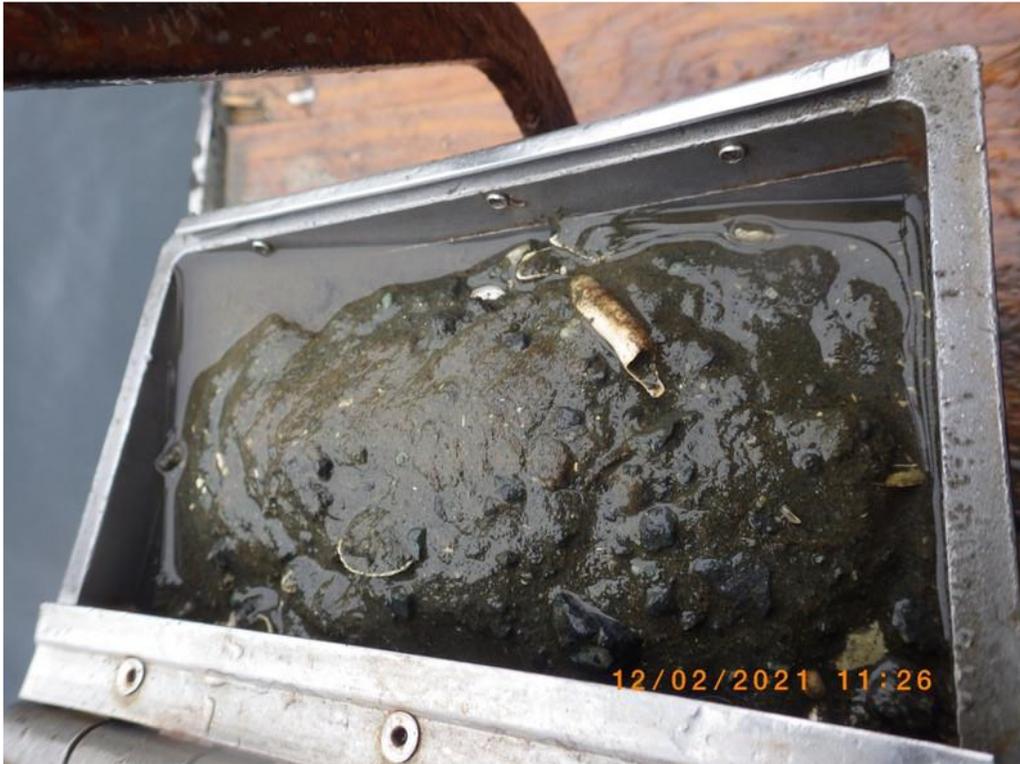
Photo 9

Sediment sample collected at Reference 2 at the Hecate Channel site on February 12, 2021.
