Reaction to fire test report

Test standard: AS ISO 9705:2003 (R2016)

Product: DecorZen – FR MDF, AP250S profile, 8 mm perforation, Tasmanian Oak veneer

Job number: RTF210373

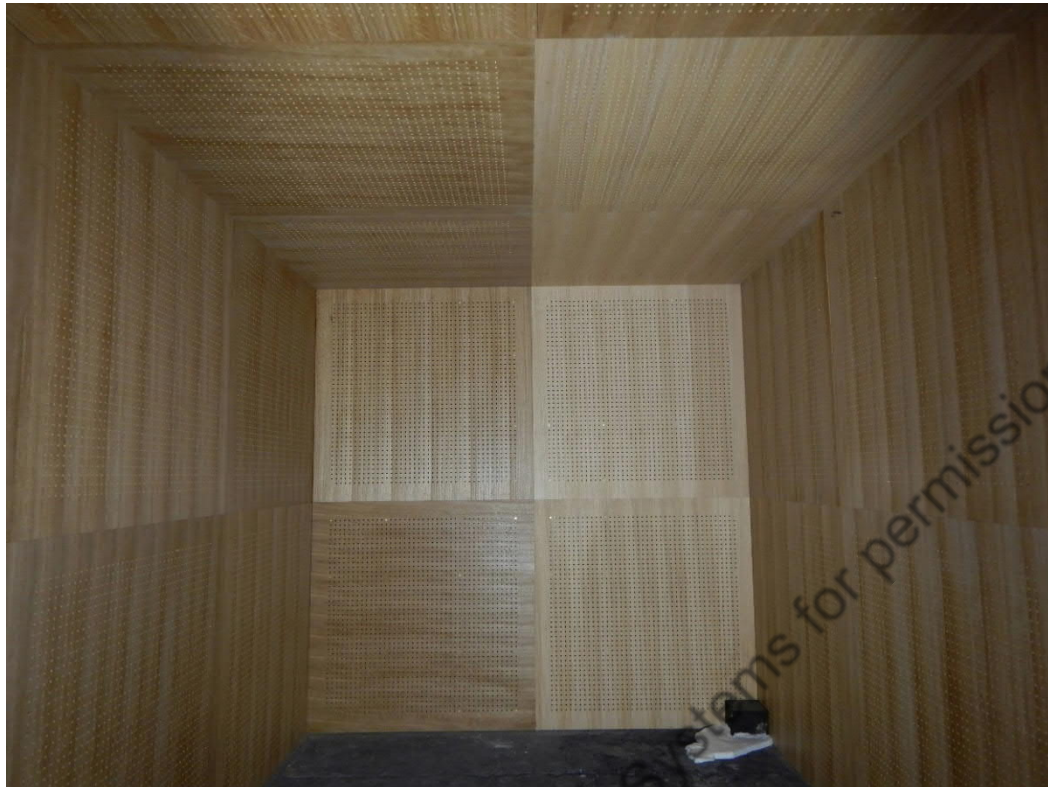
Figure 15 The specimen before the reaction to fire test

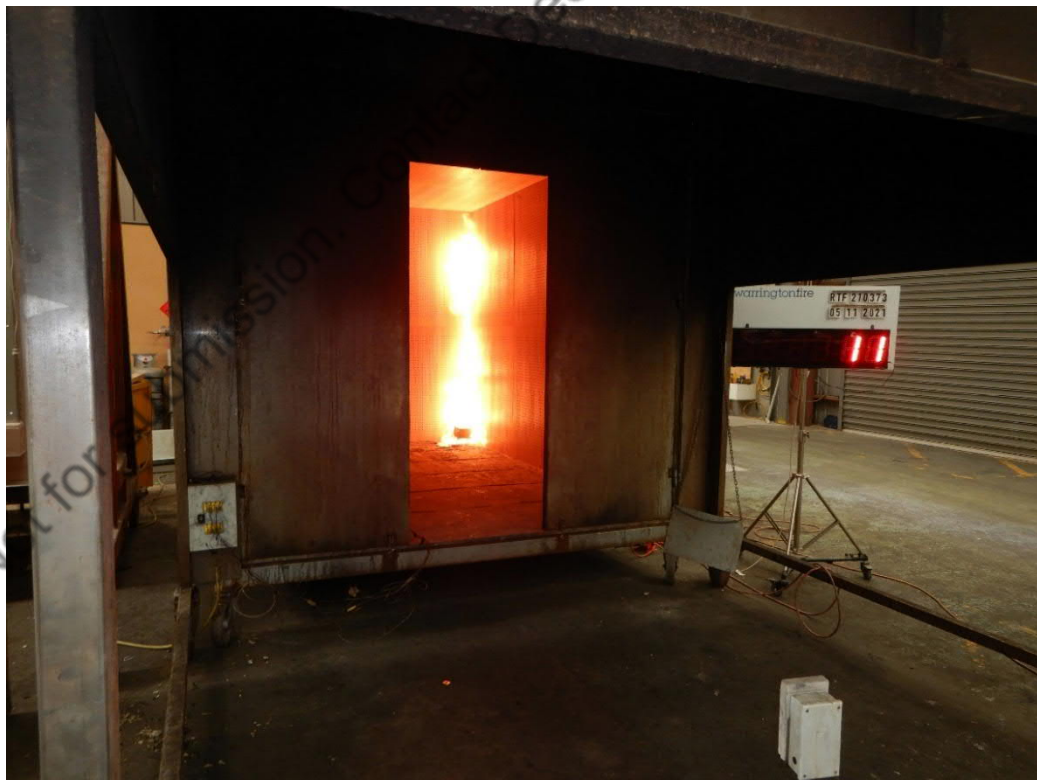
Figure 16 The specimen 11 seconds after burner ignition with the burner output of 100 kW

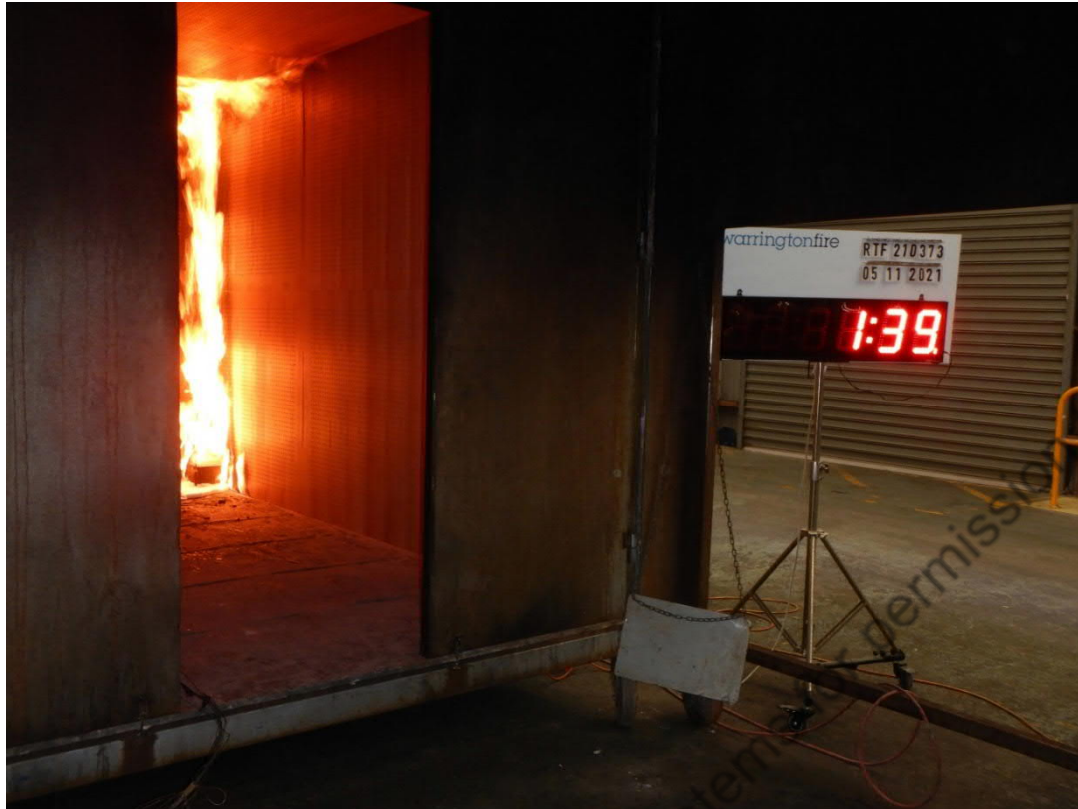
Figure 17 The specimen 1 minute 39 seconds after burner ignition with the burner output of 100 kW

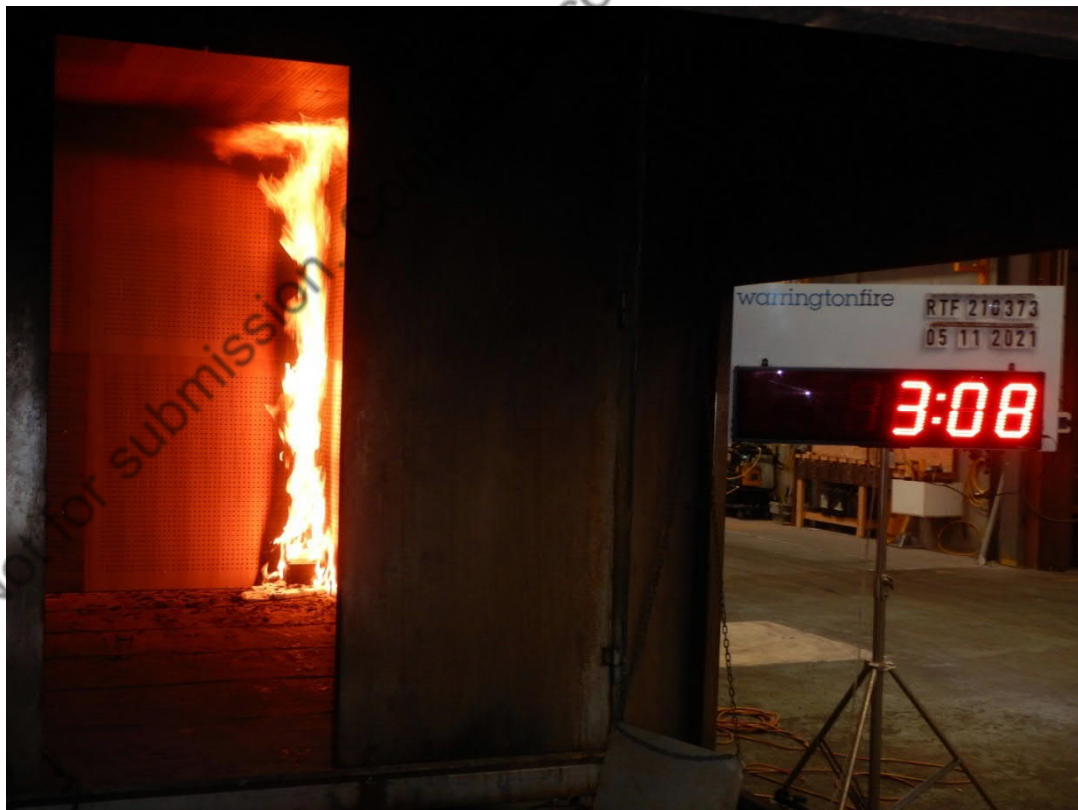
Figure 18 The specimen 3 minutes 8 seconds after burner ignition with the burner output of 100 kW

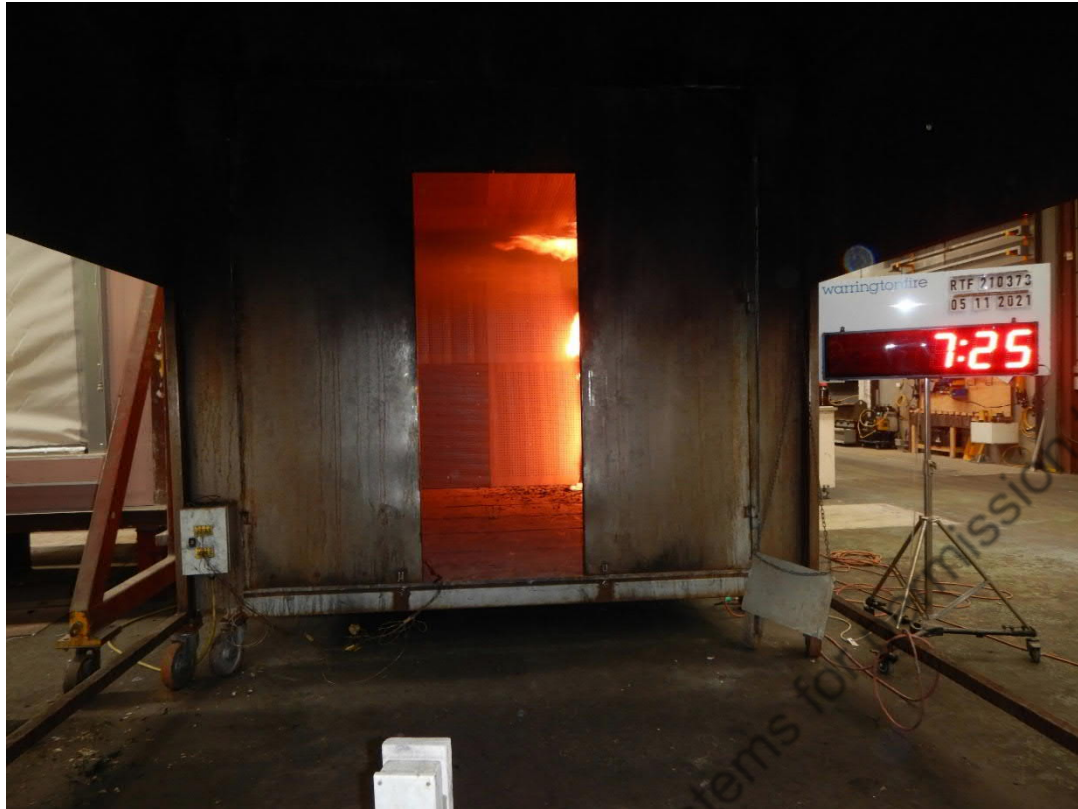
Figure 19 The specimen 7 minutes 25 seconds after burner ignition with the burner output of 100 kW

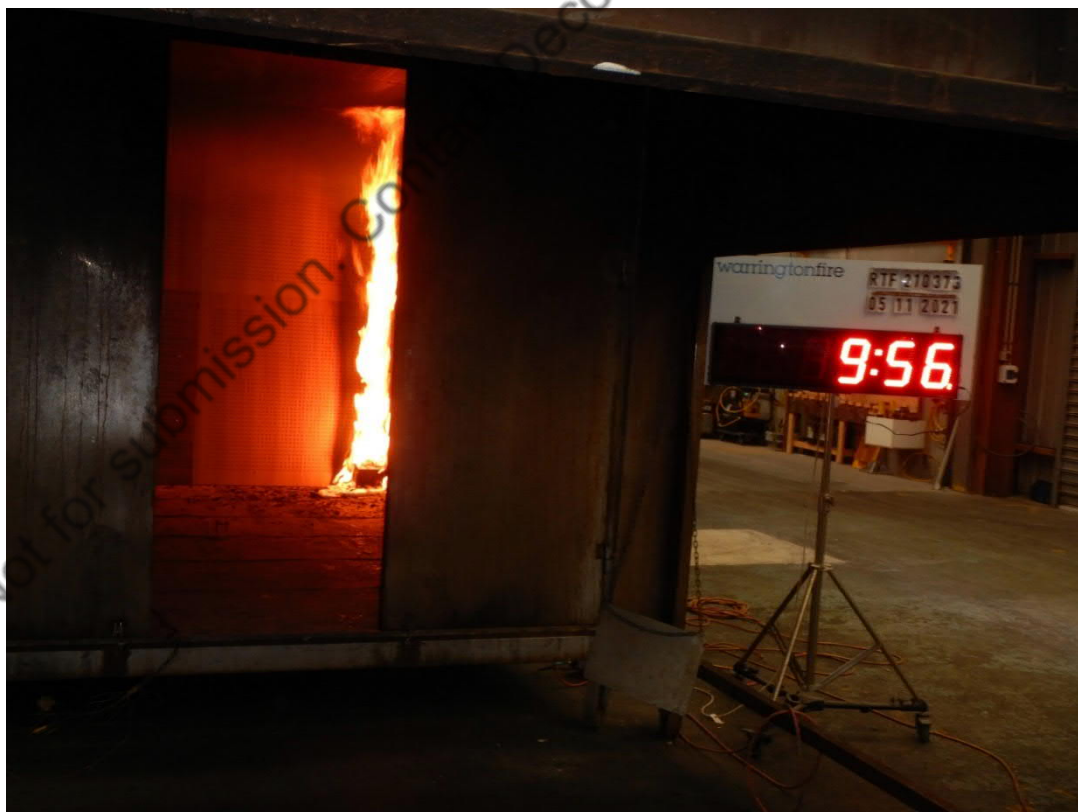
Figure 20 The specimen 9 minutes 56 seconds after burner ignition with the burner output of 100 kW

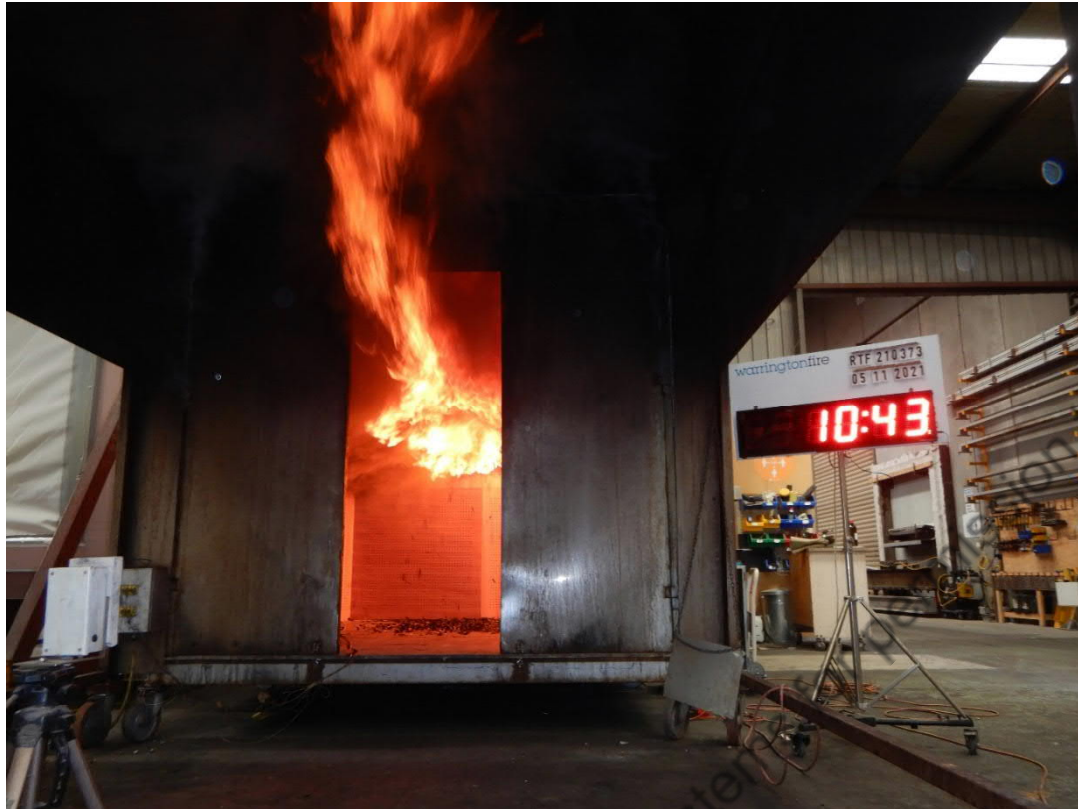
Figure 21 The specimen after flashover (43 seconds after burner output was increased to 300 kW)

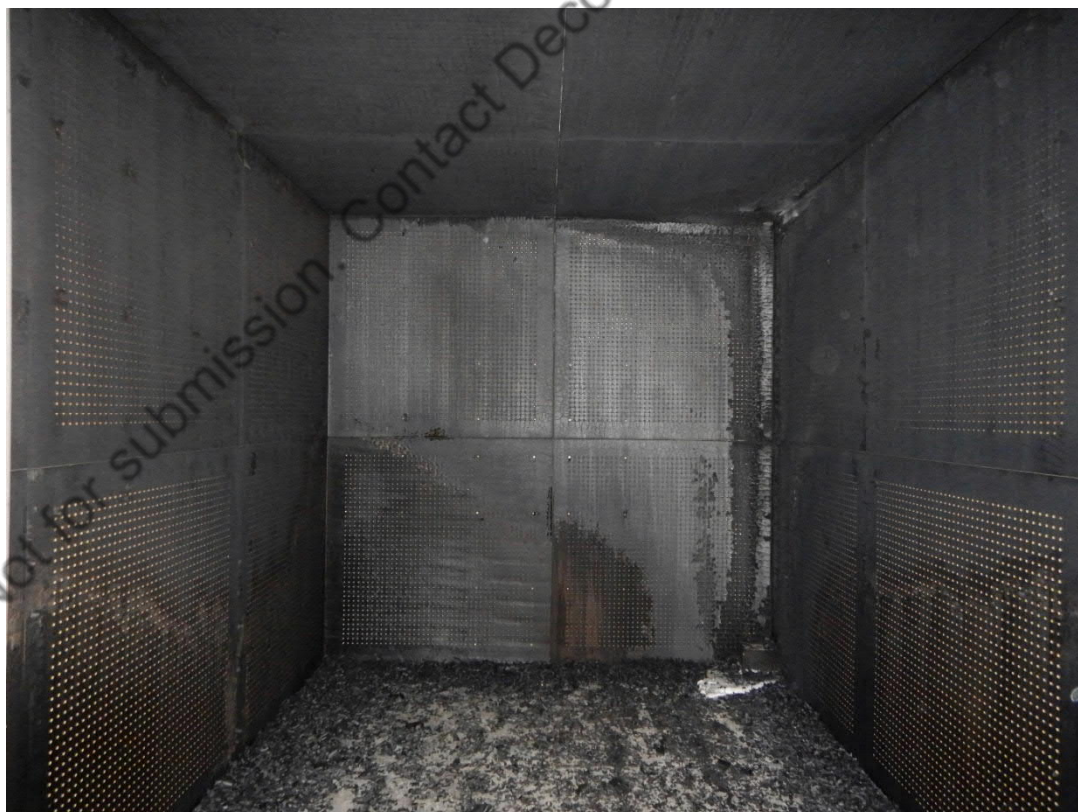
Figure 22 The specimen after the reaction to fire test
