FINFISH AQUACULTURE SITE AQUACULTURE STEWARDSHIP COUNCIL REPORT WILLIAMSON PASSAGE, MUCHALAT INLET, BC

SITE LICENSE: AQ1705 SURVEY TYPE: ASC SURVEY DATE: JANUARY 24, 2020 REPORT DATE: FEBRUARY 13, 2020

GRIEG SEAFOOD BC, LTD #106 3001 IRONWOOD STREET CAMPBELL RIVER, BC V9W 5P7

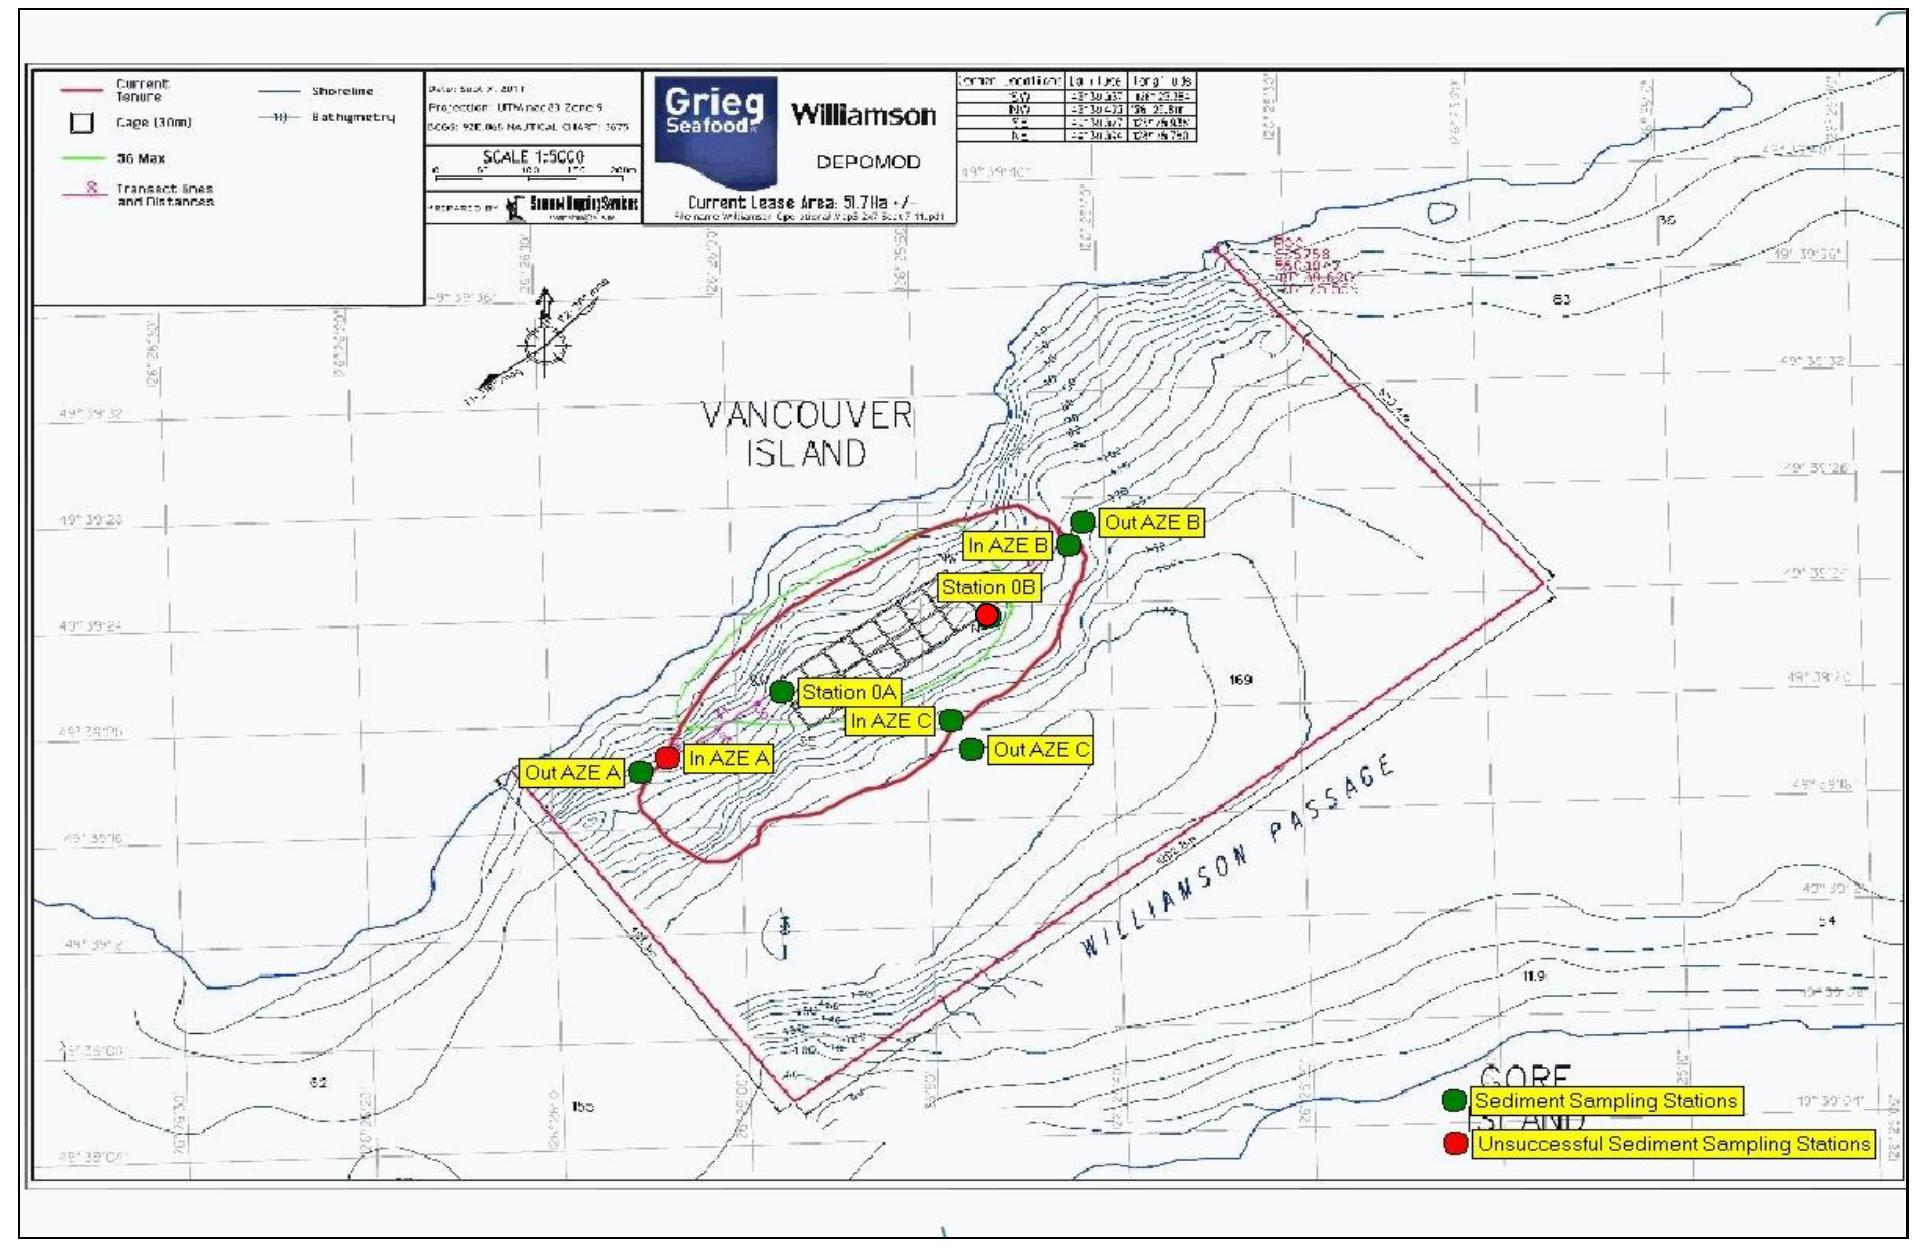
Figure 2: The locations of the sampling stations for the ASC survey at the Williamson Passage finfish aquaculture site in relation to the pen system and surrounding area on January 24, 2020.

Individual sediment sampling stations were located along three Transects A, B, and C. Stations within the AZE were located 5 m inside the 1 g DEPOMOD contour (Figure 2) for all three transects and also at the perimeter of the containment system for Transects A and B. Stations outside the AZE were located 25 m outside of the 1 g DEPOMOD contour. Additional stations were established at two reference outside the range of 500 m to 1000 m from the aquaculture containment system outlined in the ASC Salmon Standard (Figure 3) due to the difficulty in finding sediment within that area in Muchalat Inlet, BC.

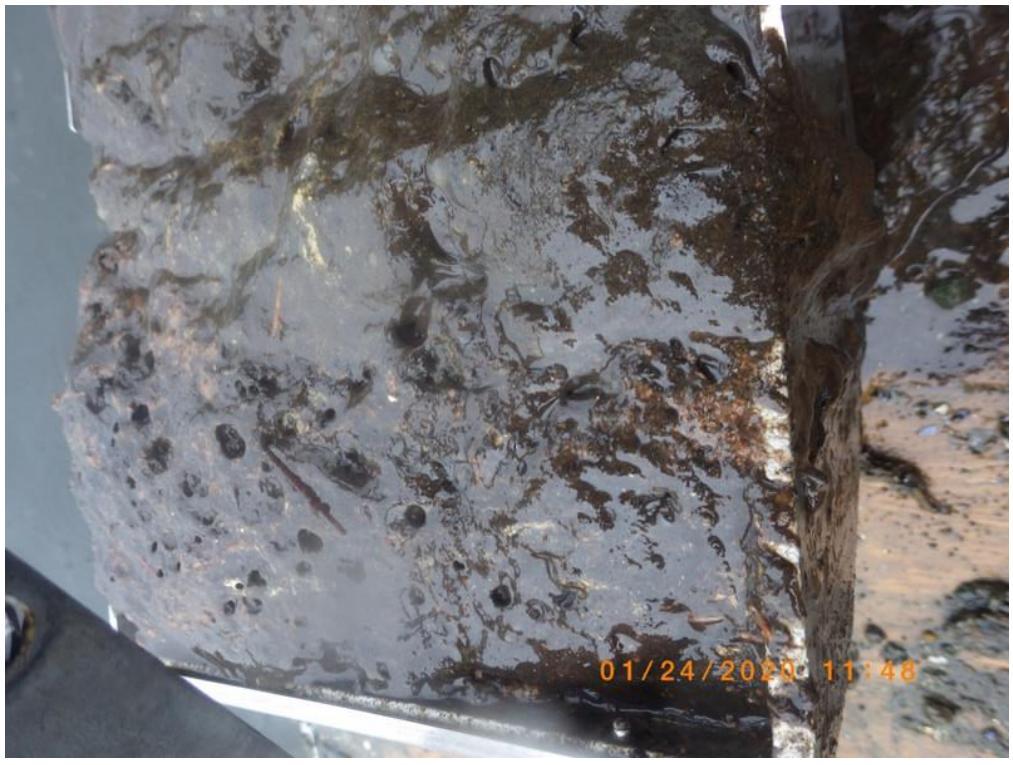
Photo 1

Sediment sample collected at the 0m station on Transect A at the Williamson Passage site on January 24, 2020.

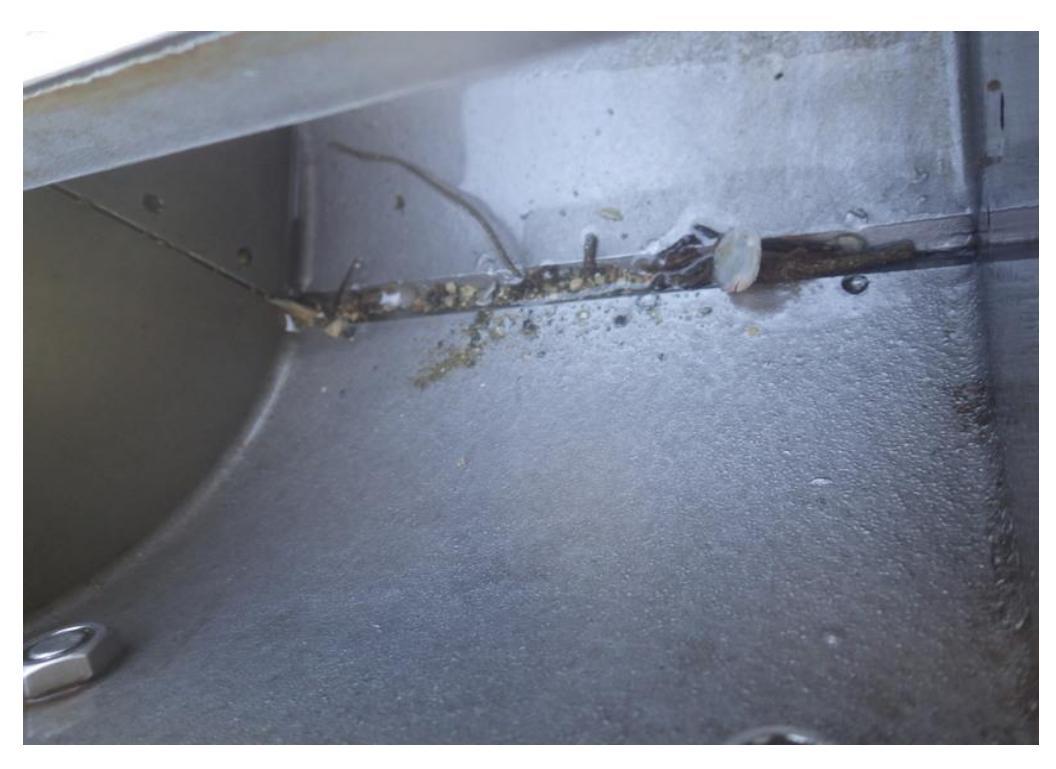
Photo 2

On June 20 and 21, 2019 during a preliminary survey a total of four grab attempts were made inside the AZE on Transects A. All of the attempts were unsuccessful in obtaining sufficient sediment for analysis. The location and results of each of the unsuccessful grab attempts are presented in Table 2.

Typical missed grab attempt at the station inside the AZE on Transect A at the Williamson Passage site on June 20, 2019.

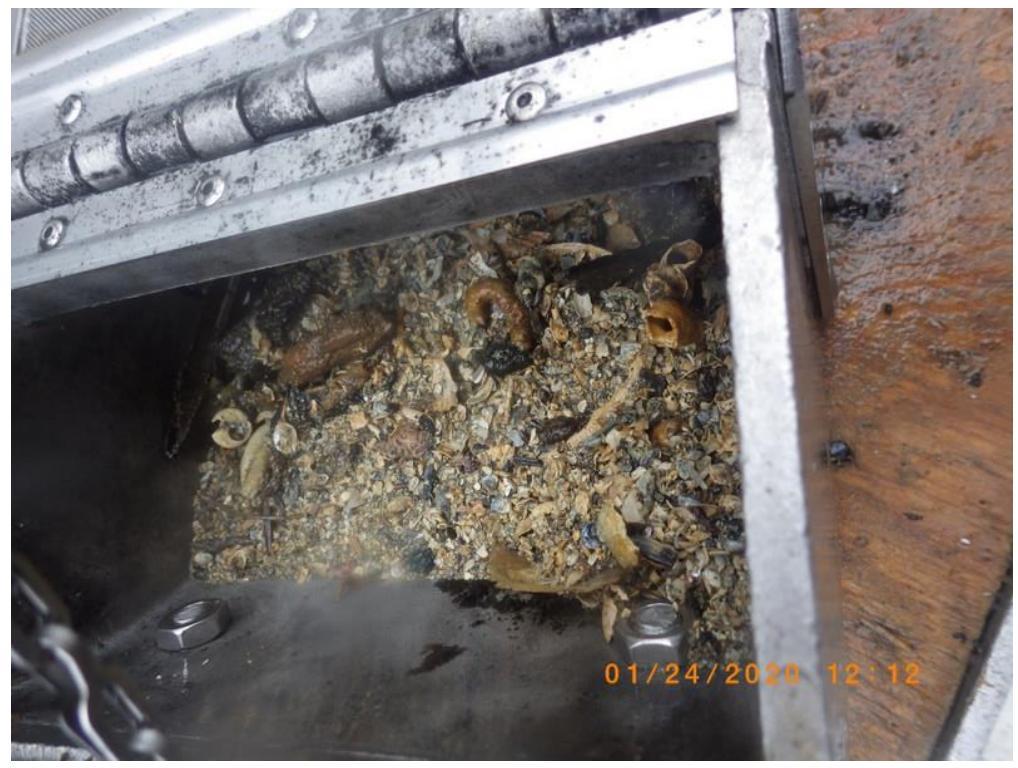
Photo 3

Sediment sample collected at the station outside the AZE on Transect A at the Williamson Passage site on January 24, 2020.

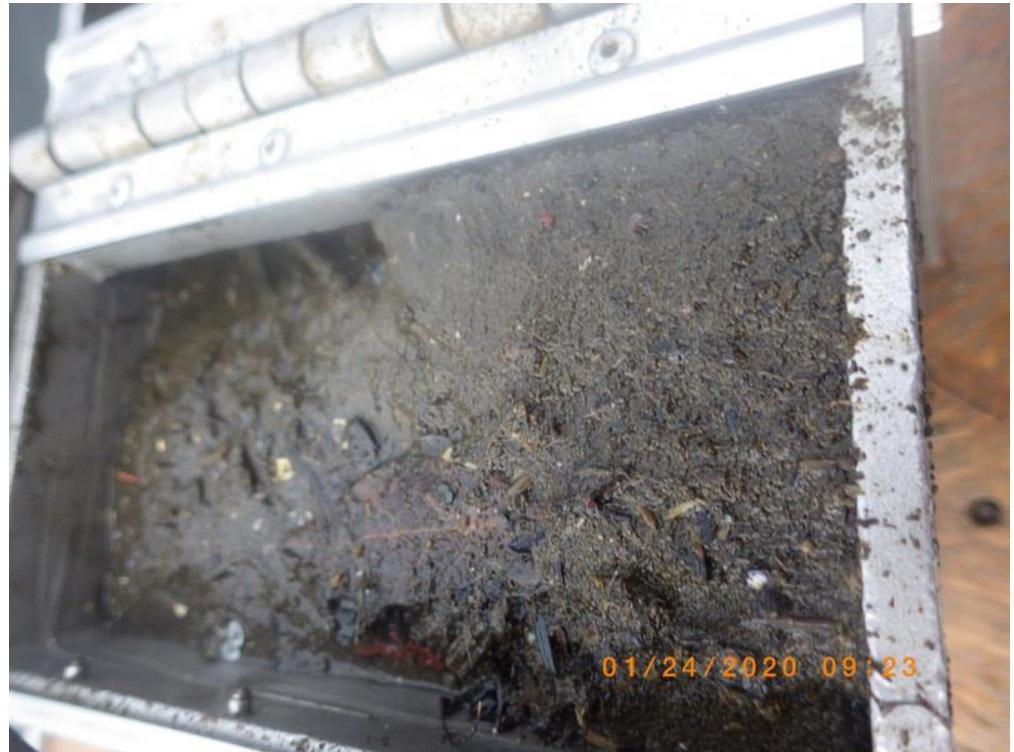
Photo 4

Sediment sample collected at the station inside the AZE on Transect B at the Williamson Passage site on January 24, 2020.

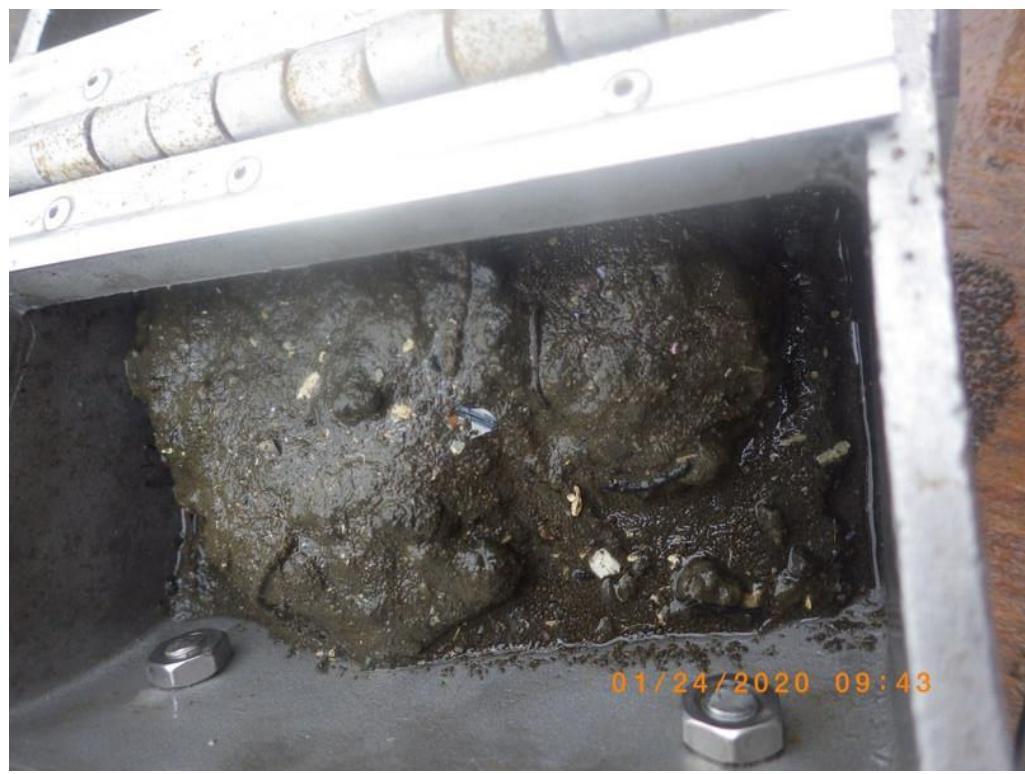
Photo 5

The mean copper concentration measured at the station outside the AZE on Transect B (112 mg/g) was higher than 34 mg/g and greater than both reference stations and therefore the benthic conditions at this location did not meet the ASC Salmon Standard in accordance with Criterion number 4.7.4.

Sediment sample collected at the station outside the AZE on Transect B at the Williamson Passage site on January 24, 2020.

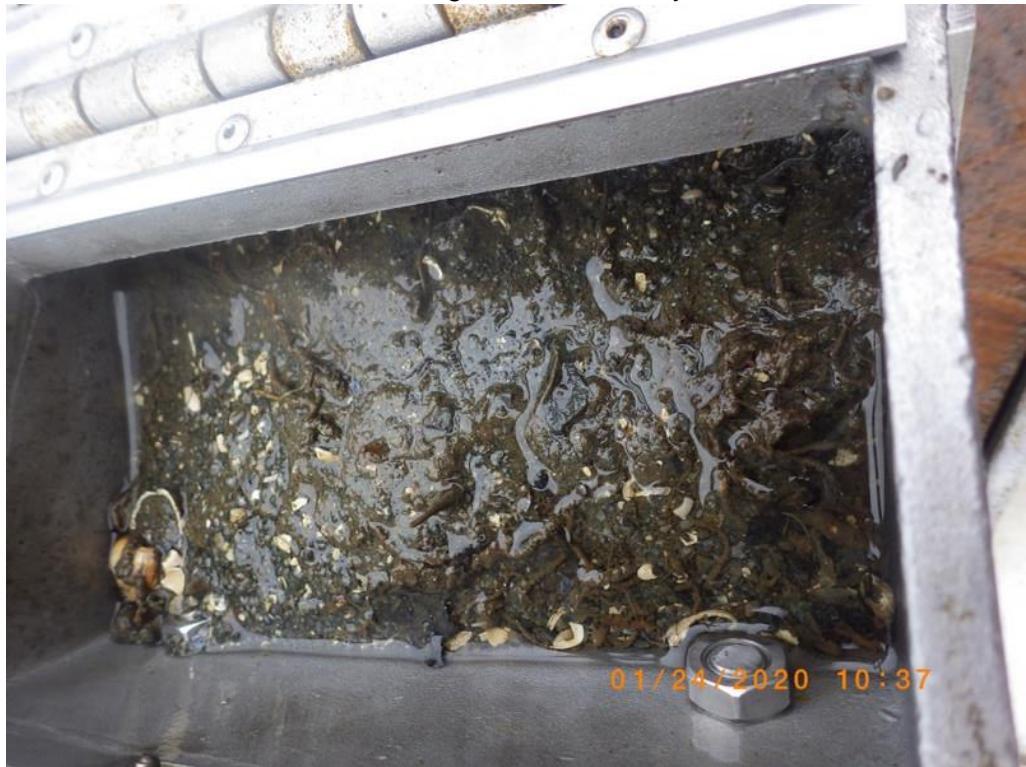
Photo 6

Sediment sample collected at the station inside the AZE on Transect C at the Williamson Passage site on January 24, 2020.

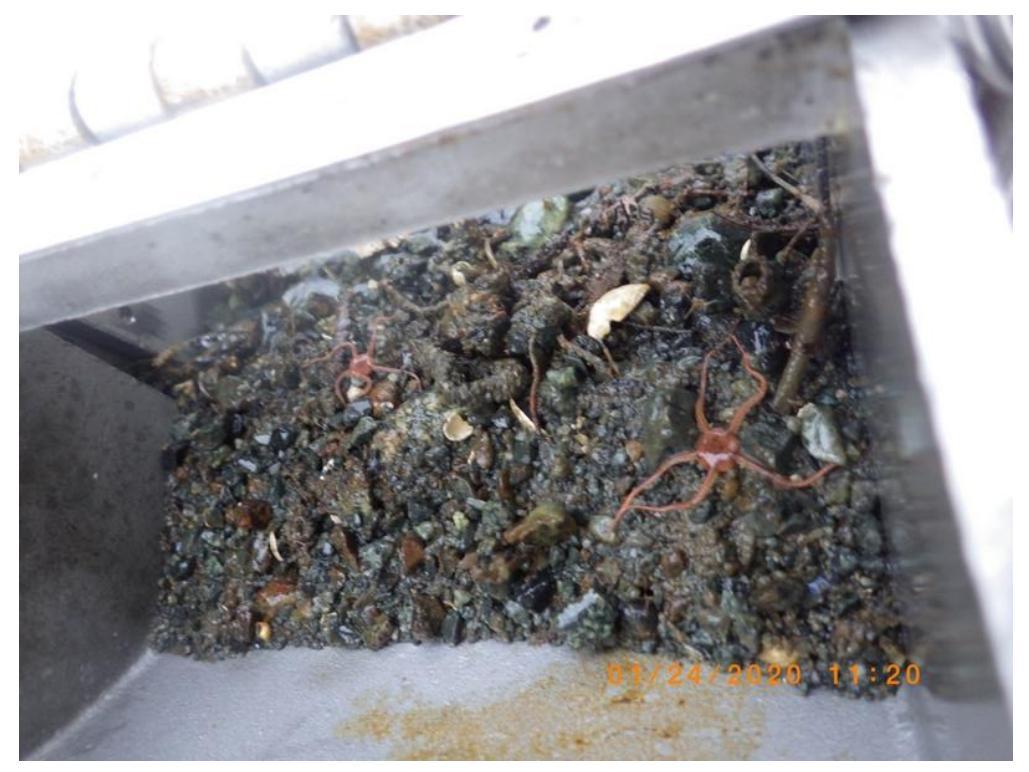
Photo 7

Sediment sample collected at the station outside the AZE on Transect C at the Williamson Passage site on January 24, 2020.

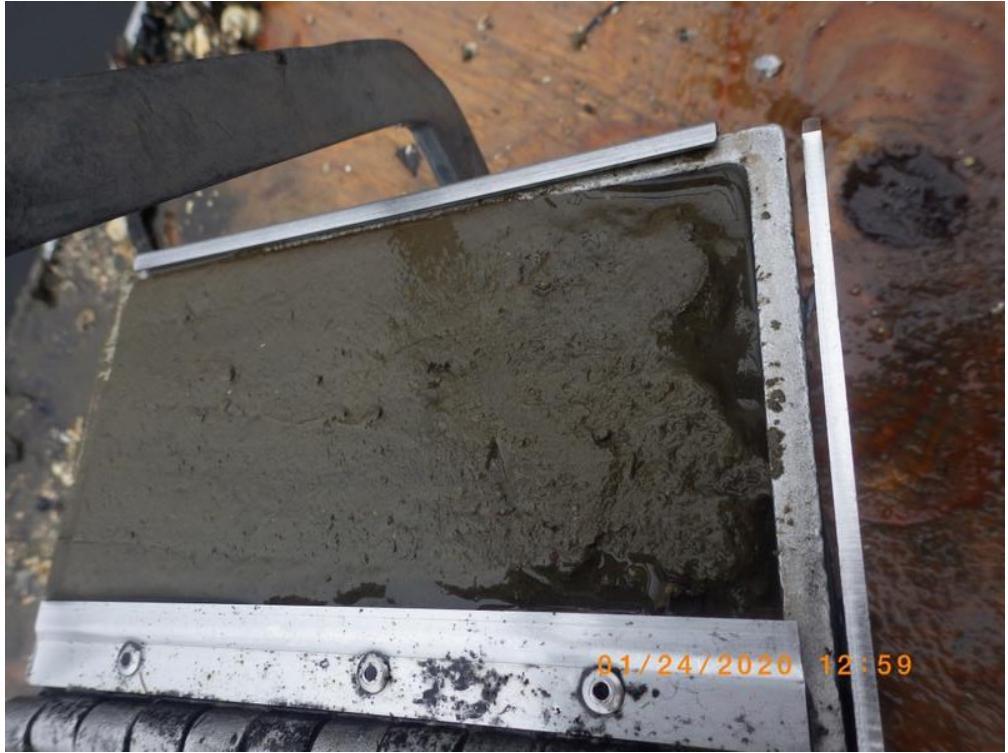
Photo 8

Sediment sample collected at the Reference 1 station at the Williamson Passage site on January 24, 2020.

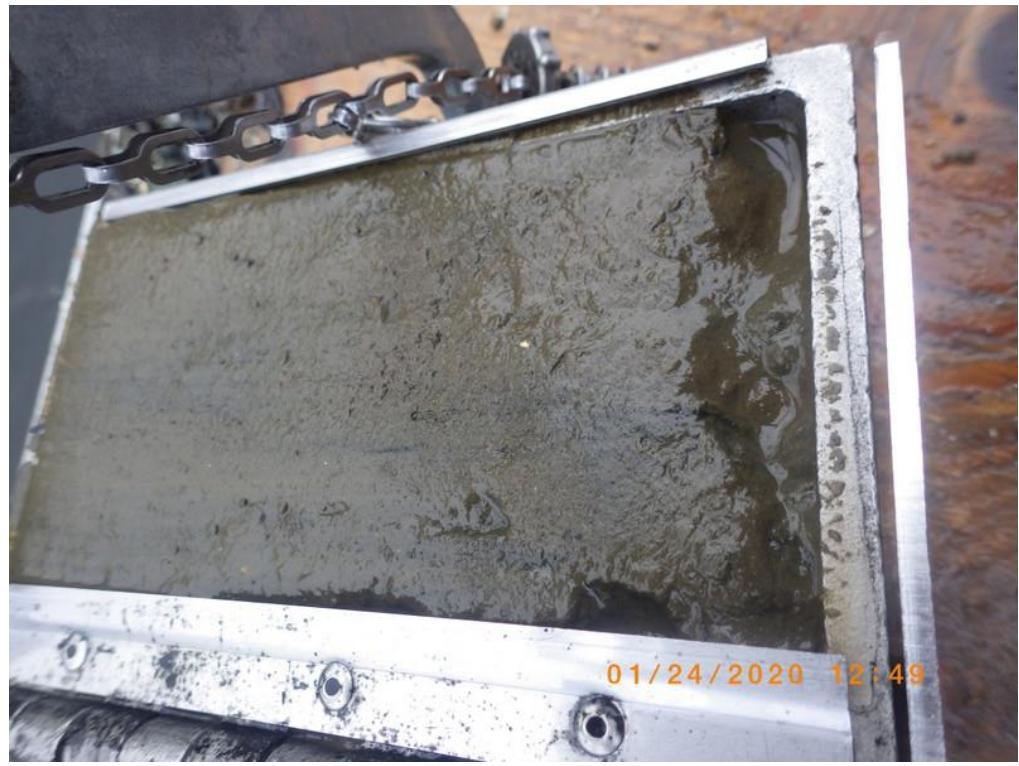
Photo 9

Sediment sample collected at the Reference 2 at the Williamson Passage site on January 24, 2020.

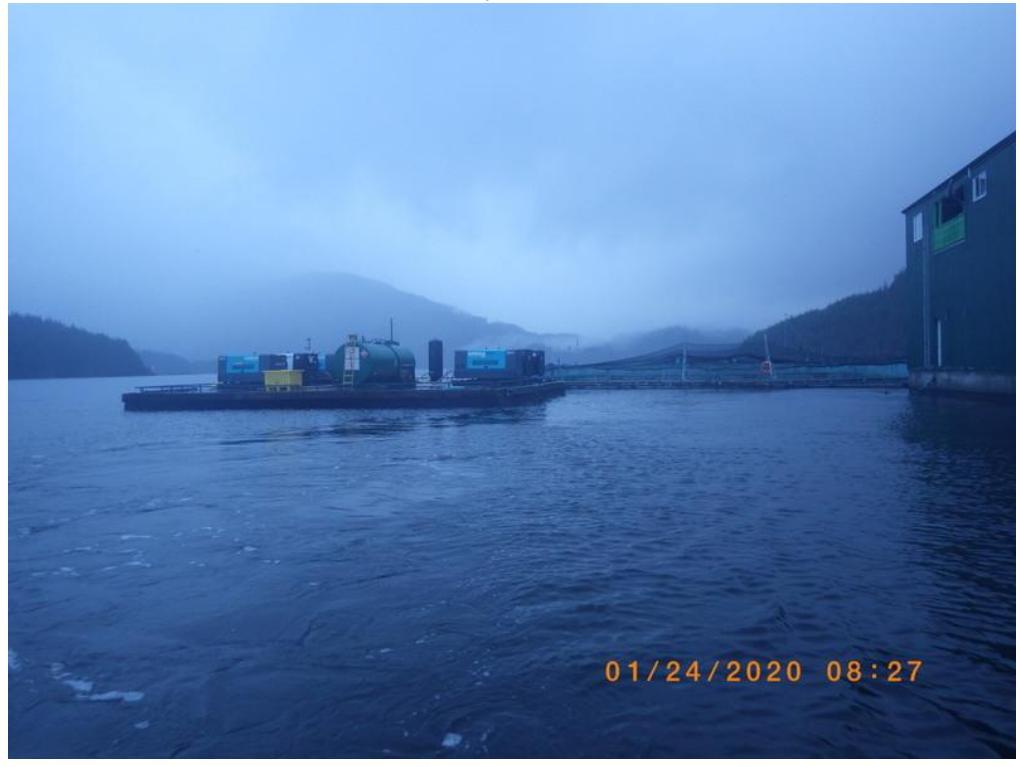
Photo 10

The results of the preliminary assessment concluded that sediment could not be successfully obtained at the station inside the AZE on Transect A. During this survey the collection of sediment could not be completed at the 0m station on Transect B because a generator float had been placed over the sample location (Photo 10).

The generator float blocking access to the 0m station on Transect B at the Williamson Passage site on January 24, 2020.
